# Virginia Department of Forestry BMP Effort, Implementation, and Effectiveness Field Audit

•  
June 2003

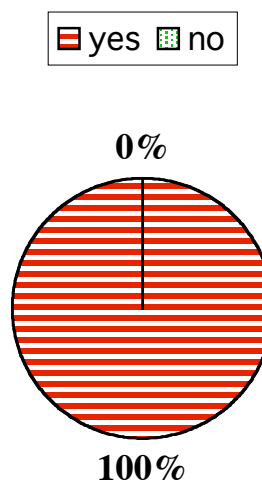
Efforts to implement BMPs were evident at 100% of inspected timber harvests, an increase from the 93% recorded in November 2002, (*fig.1*). Quality of effort, rated on a scale of 1(poor) to 5(excellent), averaged 3.1, up from the 2.9 average of November 2002. Implementation of all necessary BMPs to DOF standards occurred at

**Fig. 1: Has An Effort Been Made To Apply BMPs, Regardless Of Meeting Technical Specifications?**

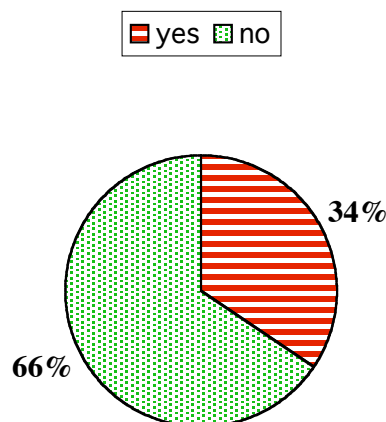
34% of inspected sites, the highest rate recorded to-date, (*fig. 2*).

**Fig. 2: Were All BMPs Applied To Technical Specifications As Expressed In The BMP Manual?**

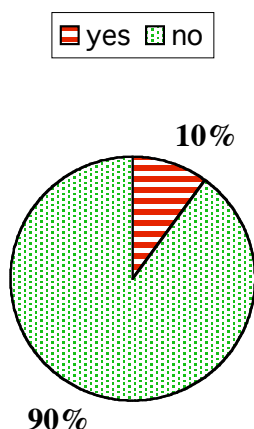
Active sedimentation existed at 10% of the inspected sites; down from 17% in November 2002, (*fig. 3*). The potential for sedimentation was noted at 10% of the inspected sites, equal to the 10% noted in November 2002, (*fig. 4*).

**Fig. 3: Does Active Sedimentation Exist Now Because BMP Technical Specifications Were Not Met?**

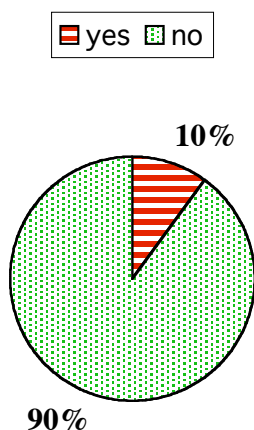
**Fig. 4: Does The Potential Exist For Active Sedimentation To Develop Because BMP Technical Specifications Were Not Met?**
